Sunroof Water Leak Bulletin

1984-86 FIERO (WITH AD3) Conditions, which contribute to water leaks on 1984 to 1986 Fiero sunroofs, can be repaired by adding drainage holes to the plastic roof outer panel and replacement of hardware nuts at the hinge and latch locations on the glass panel.

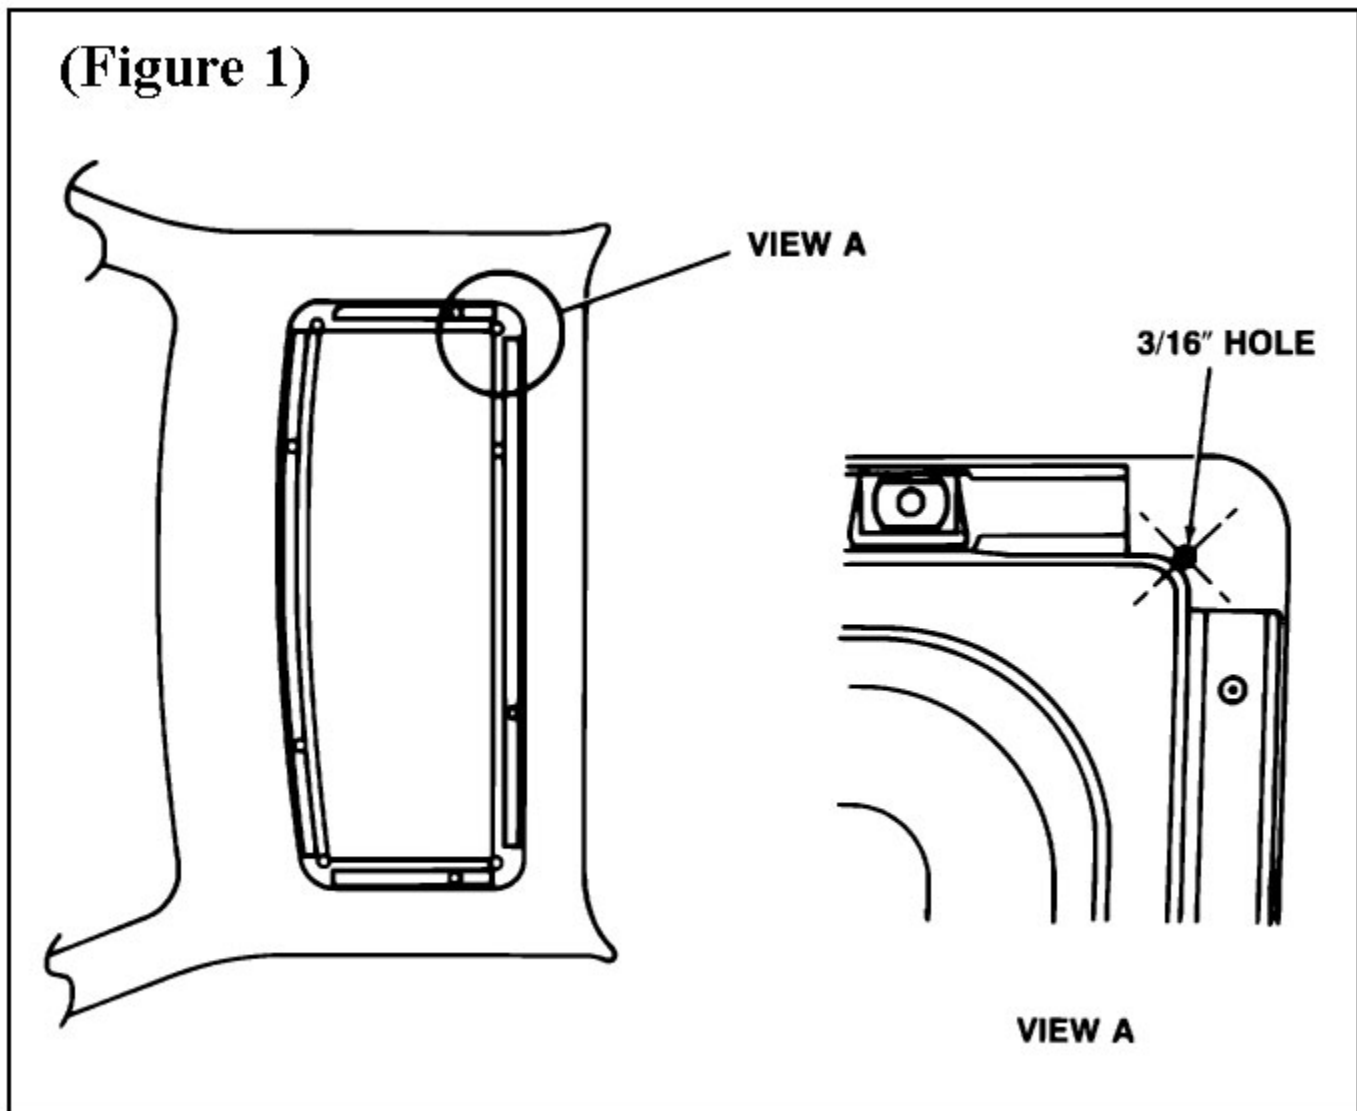
The addition of holes provides a water drain system and are to be drilled through the Plastic Roof Outer Panel Only. The holes are to be located in all four (4) corners of the weatherstrip mounting area. Figure 1 shows the location of the holes with the weatherstrip removed for illustrative purposes.

The recommended procedure for adding holes to the roof outer panel is as follows:

1. Remove the sunroof glass assembly from the vehicle and place on a clean work surface.

2. During the following drilling operations, it will be necessary to hold the weatherstrip out of the way to prevent damage. Using a drill and 3/16" drill bit, drill one hole (through the plastic roof outer panel only) in each corner of the weatherstrip cavity as shown above in Figure 1, view A.

3. Reinstall the sunroof glass assembly to the vehicle and water test to insure an acceptable repair.

4. After water testing, remove the sunroof glass and dry the roof inner panel by blowing compressed air through the holes in the roof outer panel. Apply a small amount of GM P/N 1052856 anti-corrosion compound (or equivalent) through the holes in the roof outer panel to protect the metal roof inner panel from corrosion caused by damage done during drilling operations.

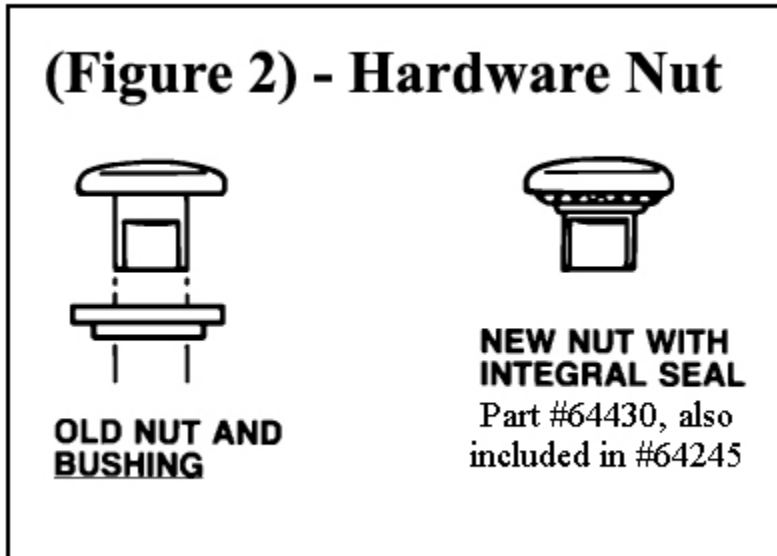
If water leaks are noted at the hinge and latch locations, a new hardware nut is now available and provides improved appearance and sealing. The new hardware nut has an integral seal and no longer requires the use of bushings (Figure 2). The nut come in hardware kit part #64245 or is available seperately as part #64430.

Due to the lower profile and improved appearance, the new nut should be used in all locations (hinges and latches) when service operations on sunroofs are performed.
