V6 Vacuum Line Routing

Metal Vacuum Line Set

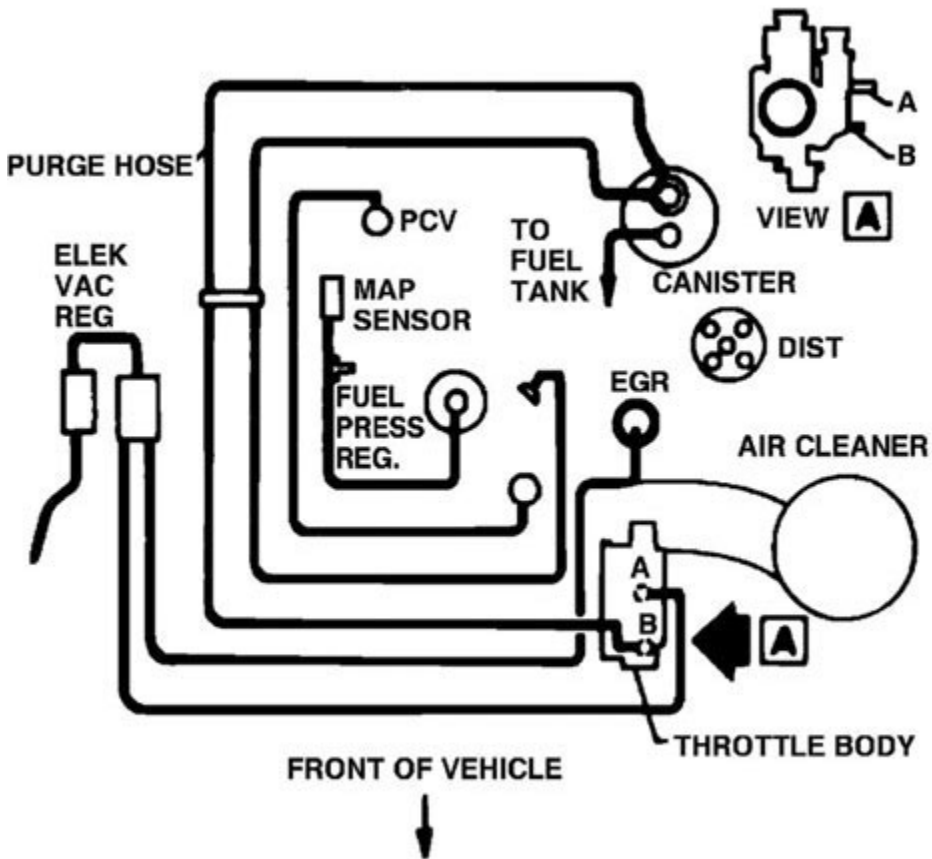
Replacing the factory plastic lines can solve many idle and running issues with the V6 engine. The plastic lines tend to get brittle with age which can cause vacuum leaks. These leaks can cause idle fluctuation, stumbling and poor fuel economy. The Fiero Store's metal vacuum line set will solve these issues and still look like factory originals.

Must re-use factory rubber fittings.  
To make fitting installation easier,  
apply a little lubricant to the end of  
each line, before pushing the rubber  
fittings in place.

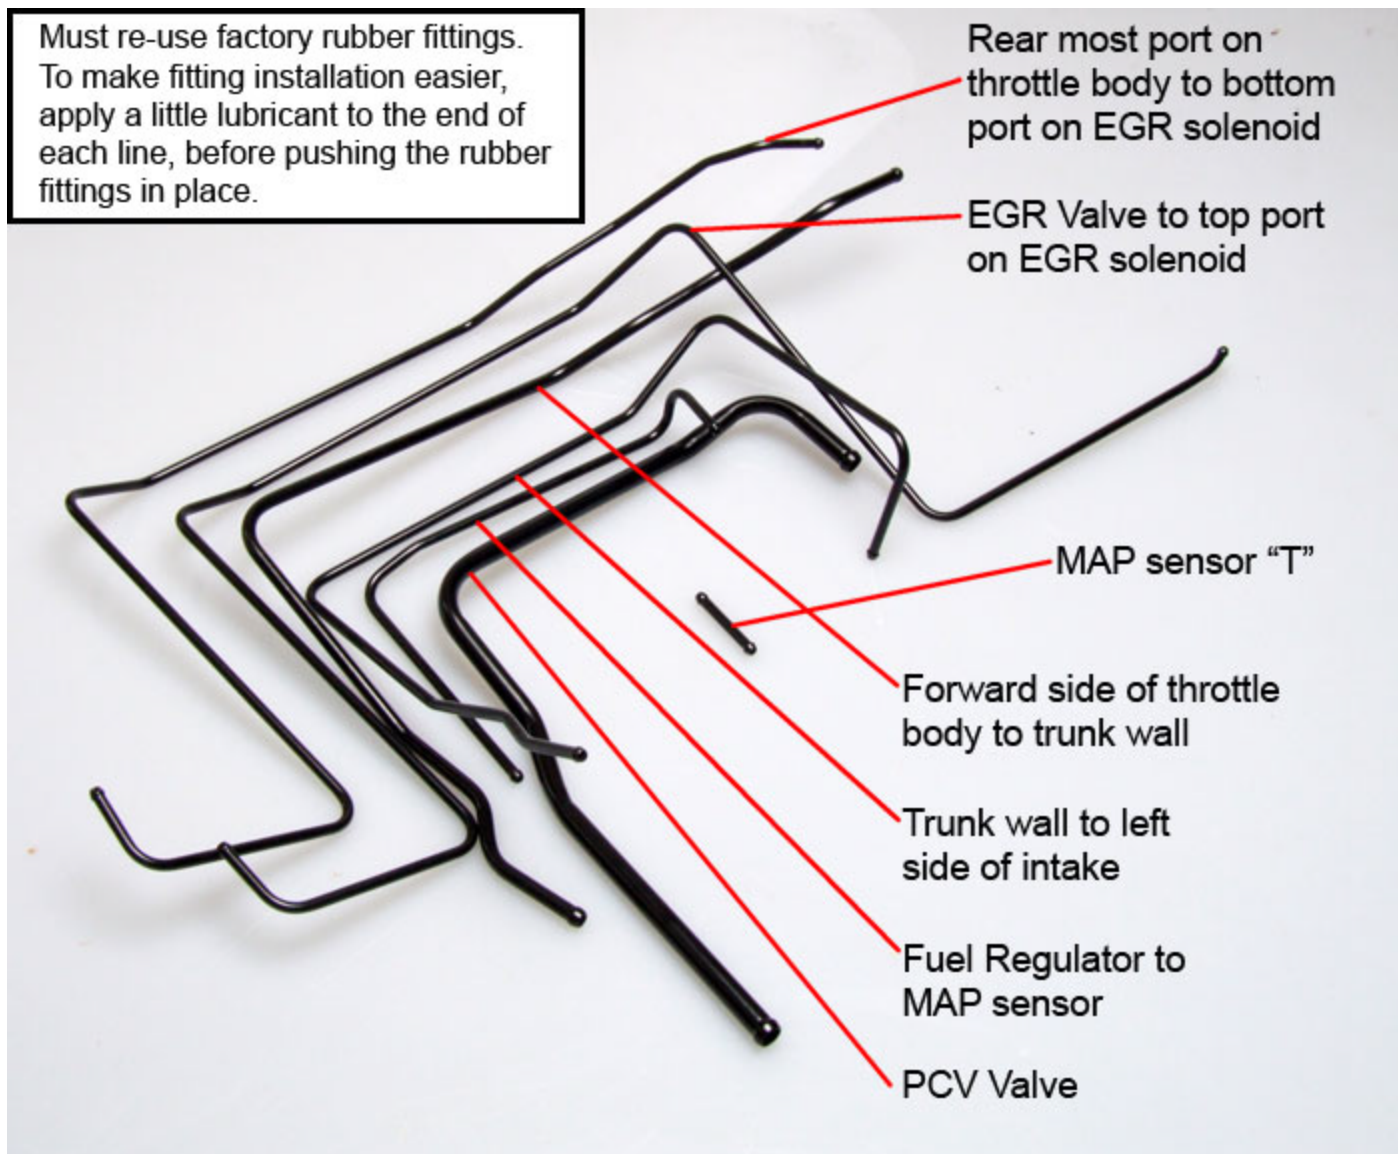
Rear most port on  
throttle body to bottom  
port on EGR solenoid

EGR Valve to top port  
on EGR solenoid

MAP sensor "T"

Forward side of throttle  
body to trunk wall

Trunk wall to left  
side of intake

Fuel Regulator to  
MAP sensor

PCV Valve
